BULLETIN

SUMMER 2006 • VOLUME 61 • NUMBER 2

- 3 TAKING ON ASME SECTION VIII, DIV. 1, PRESSURE VESSEL EFFICIENCY — *By Robert D. Schueler Jr.*
- 8 LAY-UP OF HEATING BOILERS — *By Robert Ferrell*
- 11 2005 REPORT OF VIOLATION FINDINGS
- 23 WHAT CAUSED THE ACCIDENT OF C&O LOCOMOTIVE 1642?
- 34 ELECTRONIC “UM” REGISTRATION NOW AVAILABLE FROM THE NATIONAL BOARD
- 39 ANNUAL INDEX

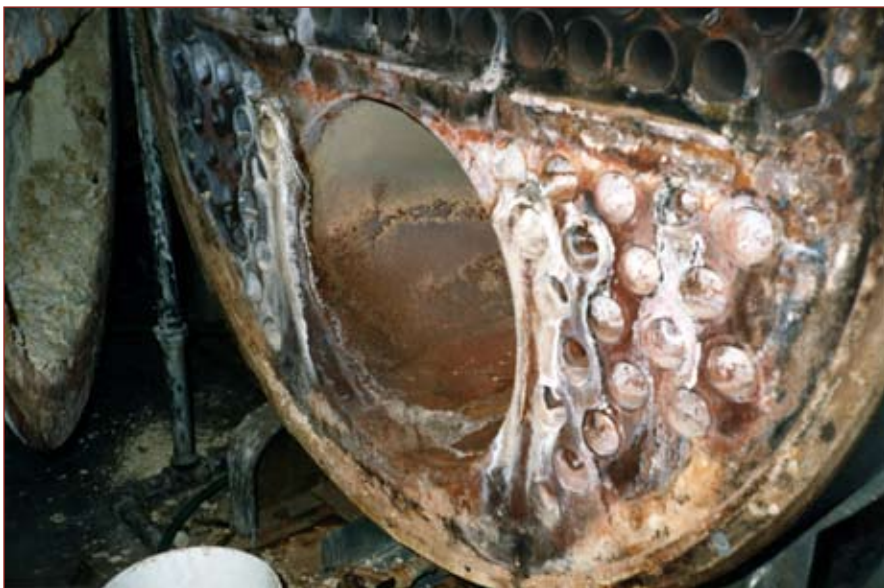
Possible leaks can be detected on the fireside of this firetube boiler. *Courtesy of Gurina Company.*

While cleaning the boiler’s fireside, look for rust (orange) or scale (grayish white) trails on the pressure boundary wall. Mark those areas for further evaluation of leakage. Look for soot trails on fireside gaskets to evaluate possible short-circuiting of combustion gases, corrosion of the gasket seating surface, and overheating of air-cooled surfaces. Discolored or chalky paint is an indication of possible overheating.

Inspect refractory and insulation on the fireside. Small cracks in refractory are normal due to expansion and contraction, especially

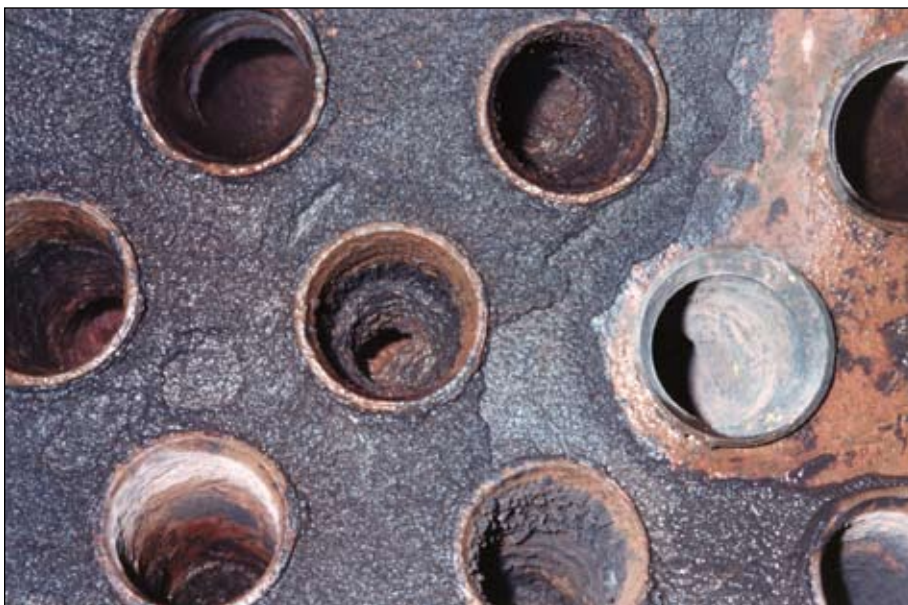
The waterside of this watertube boiler clearly shows deposits. *Courtesy of Gurina Company.*

Look for signs of gasket leakage and potential corrosion of the gasket seating surface (which could prevent a good seal). Inspect all hand-hole and manway yoke bolts and nuts for deterioration (which could prevent uniform tightening of the gasket). Using a battery-operated light, inspect the waterside (in accordance with all applicable confined space entry procedures) and evaluate the scale and corrosion condition. Wash down the boiler and attempt to move all scale and sediment out of the washout openings at the bottom of the boiler. Any scale and sediment not removed will trap moisture and oxygen and corrode the boiler.

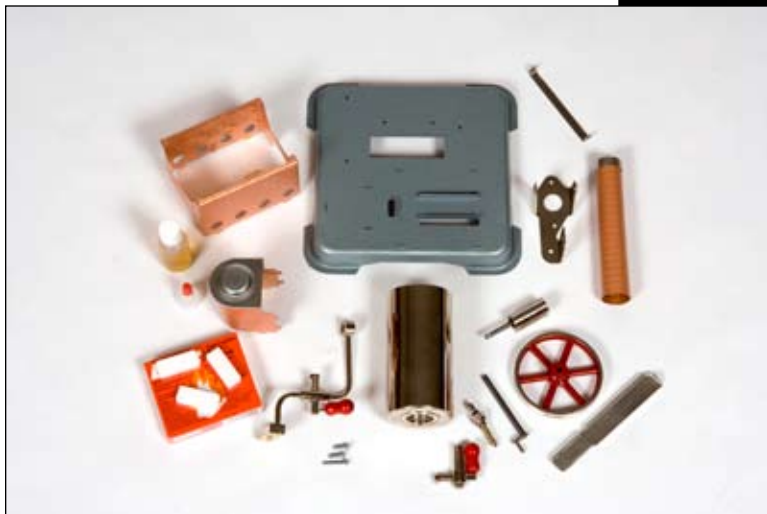
Jensen steam engine Model #76 Kit.

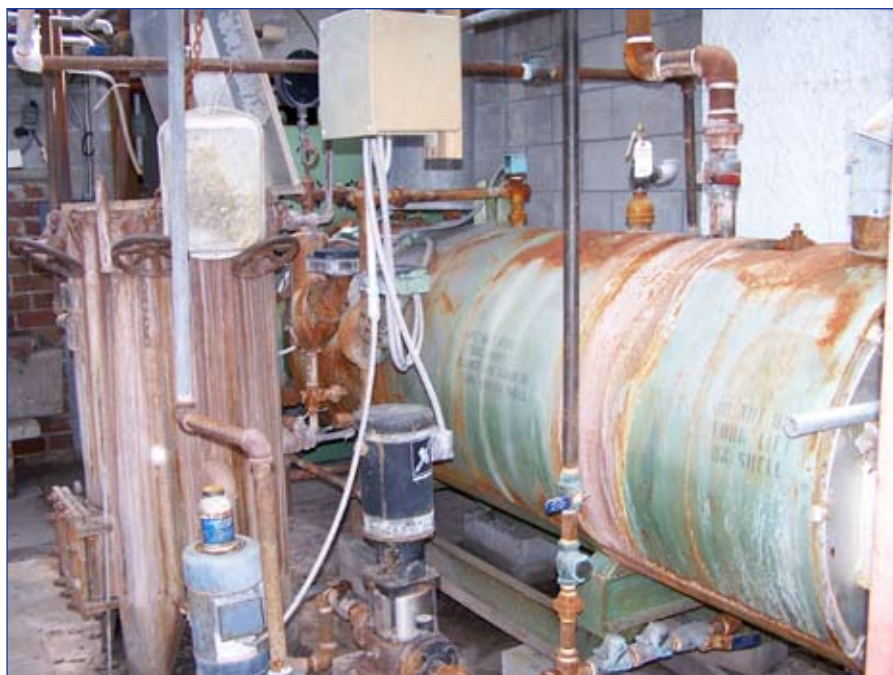
The boiler return tank/hot water preheater and boiler feed pump ruined and rusted after sitting in 6-feet-deep flood water. Equipment owned by Eric and Mary DuBuisson at Slidell Cleaners of Slidell, Louisiana.

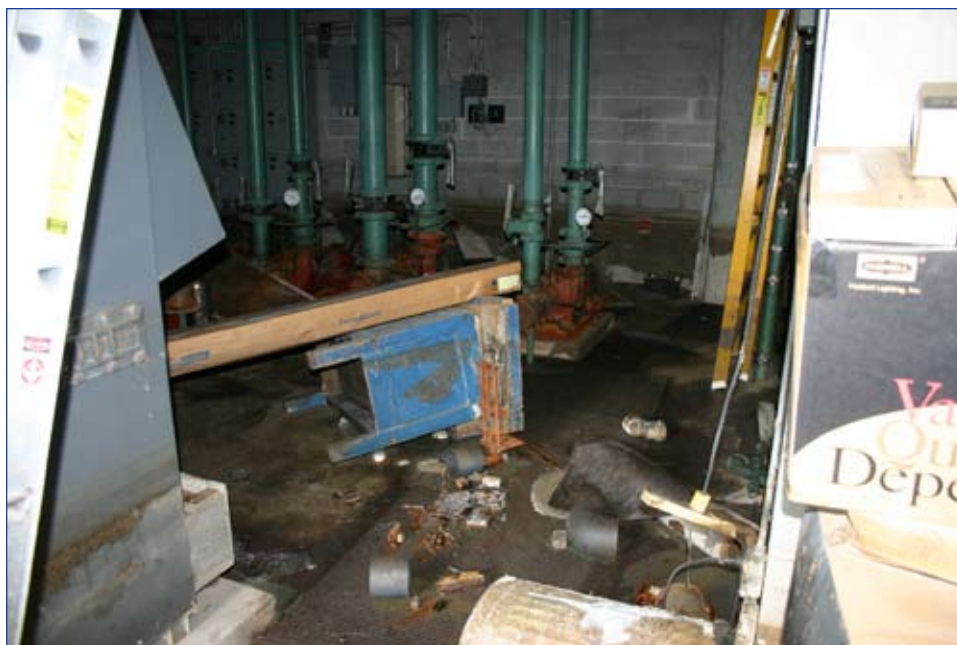
Flood damage to the mechanical room of Benjamin Franklin High School in New Orleans.

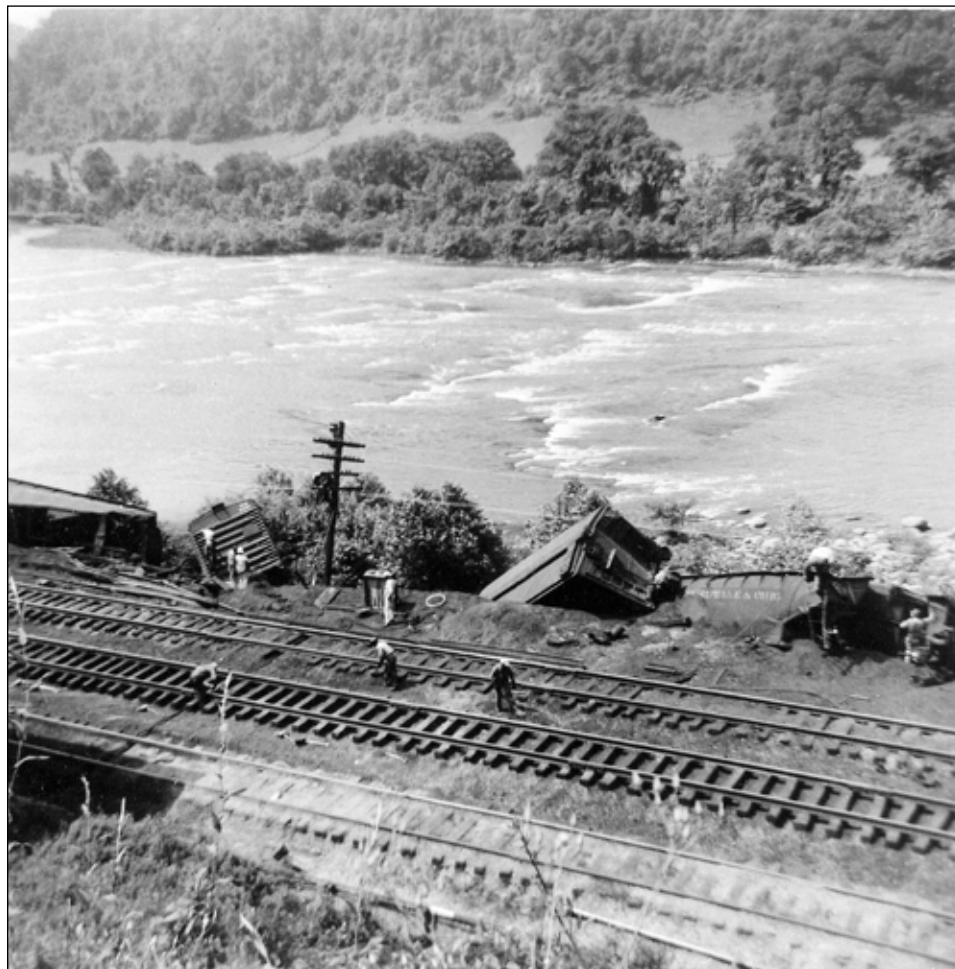
Locomotive 1642, 2-6 + 6-6 type, carrier's classification H-8 Alleghany, was built by the Lima Locomotive Works Inc., at Lima, Ohio, in December 1944. The four cylinders were 22-1/2 x 33 inches, the diameter of driving wheels 67 inches with new tires, weight in working order 771,300 pounds, weight on driving wheels 507,900 pounds, and tractive effort 110,200 pounds. The locomotive was equipped with an Alco Type H power reverse gear, American multiple front end throttle. Standard M D stoker, Franklin No. 8-A Butterfly mechanically operated fire door, Baker valve gear, Worthington Type 6-1/2 SSA feedwater pump, Nathan Type 4000-C special injector. The boiler was equipped with a Nathan Type B low water alarm and there were three Nicholson thermac siphons in the firebox. Locomotive had made 97,000 miles since last Class 3 repairs and 18,000 miles

since last Class 5 repairs. The rectangular cast-steel water-bottom tender had capacity of 25,000 gallons of water and 25 tons of coal.

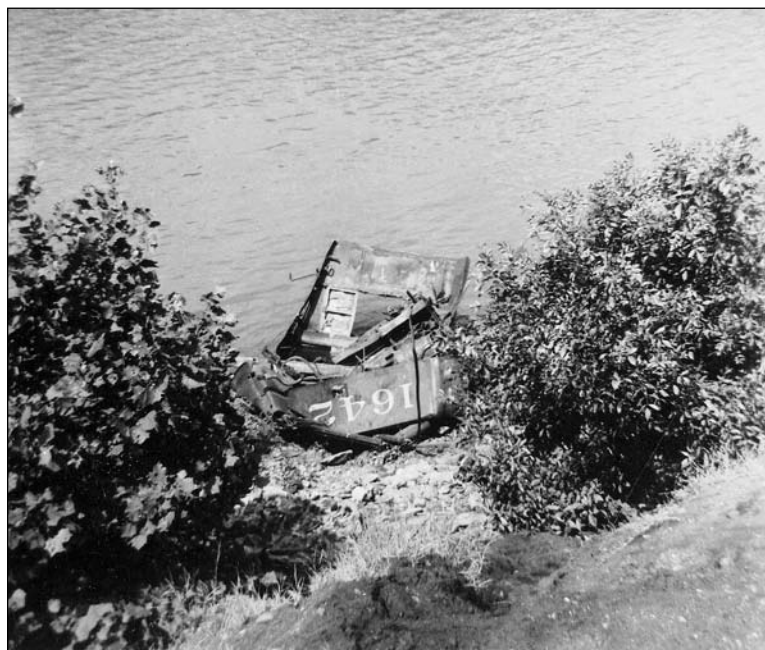
Irregular tears practically crossed the crown sheet between the 24th and 28th transverse rows of stays and extended down in the side sheets to about the 20th longitudinal rows of stays on each side. Other irregular tears crossed crown sheet at about the 39th transverse row of stays and extended down in side sheets to about the 20th longitudinal row of stays on each side. Irregular longitudinal tears joined the ends of those transverse tears in the side sheets. The rear row of tears across crown sheet were just ahead of the thermic syphons. A large part of the torn out portion of crown sheet folded down over the throat sheet and left syphon. The three syphons were pulled out of the inner throat sheet; were badly bent and center syphon was broken through more than 50 percent of its cross-sectional areas at the neck.

The crown sheet was pulled from approximately 861 stays. A total of 1587 stays were pulled from the crown sheet, combustion chamber, and side sheets. Threads on crown stays and in stay holes appeared to have been in good condition prior to the accident. There were no broken crown stays or staybolts in firebox sheets. No crown stays or staybolts showed any indication of having been worked excessively, and all flue ends appeared to have been in good condition previous to the accident. There was a slight amount of scale on the sheets.

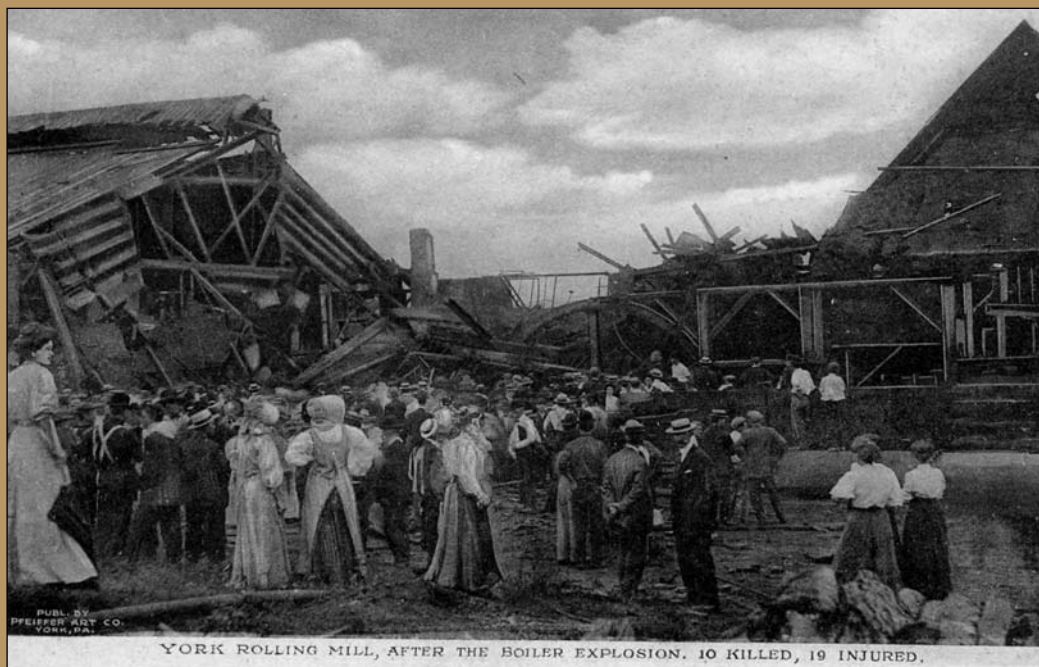
This much is known. A two hundred and fifty horse power steam boiler exploded and the rest followed. Time will tell why it exploded," stated *The Gazette* of York, Pennsylvania, on Tuesday morning, August 11, 1908. The previous afternoon brought "... by far the most disastrous accident that ever occurred in York" as the York Rolling Mill, run by the Susquehanna Iron Company, suffered an explosion of massive proportion, resulting in 10 dead, 22 injured, and incalculable damages.

Although mill officials cited a recent inspection of the boiler, it was surmised by independent officials that the boiler was in fact defective, and was known to have been secondhand when installed 12 years prior. Furthermore, the boiler was usually a reserve boiler and never had more than 35 or 40 pounds of steam carried in it. Judging from pieces found at the explosion, the boiler was badly rusted at its seams and edges and was exceptionally thin in other areas. One boiler expert declared the boiler "rotten."
