# ***Pressure Relief Device Investigation Testing – Lessons Learned***

2018 General Meeting Presentation

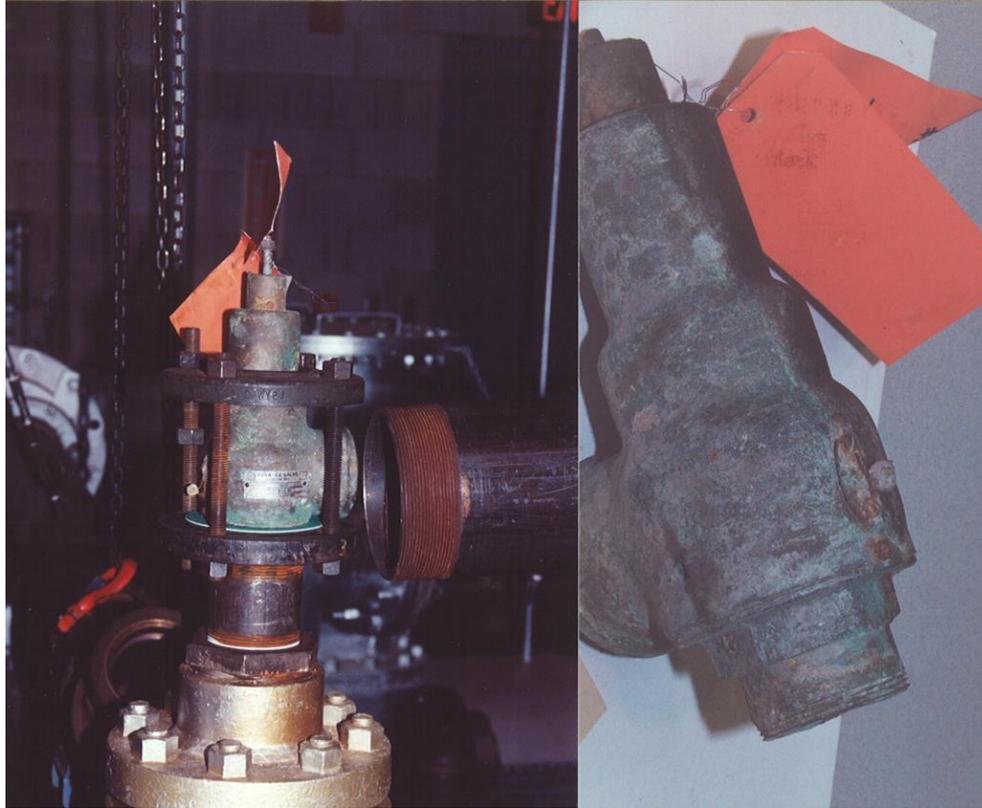
# Test rig: Valve with broken inlet

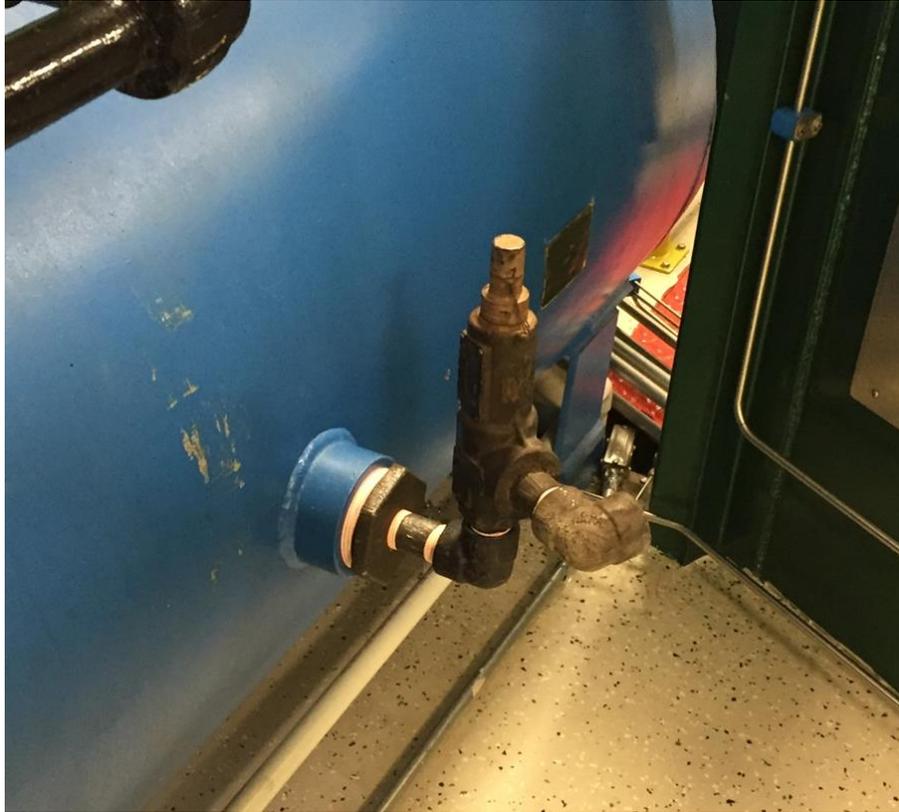
# Valve tested with supplied elbows

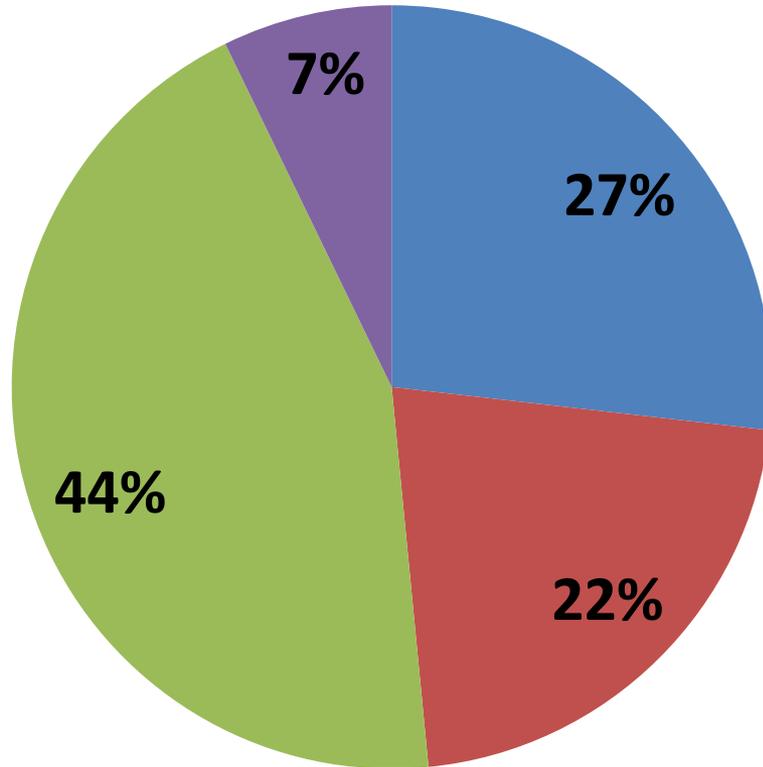
Code Sections Tested

- Section I
- Section IV
- Section VIII
- Non-Code

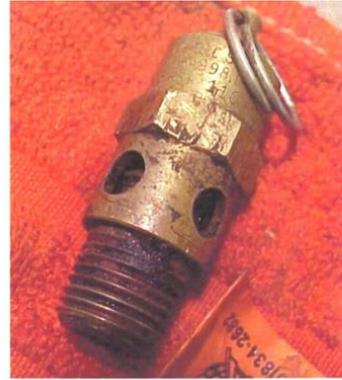
B. On receipt inlet of 125 psig valve is clogged with debris

C. After test debris is blown through valve, rubber seat of valve is missing.

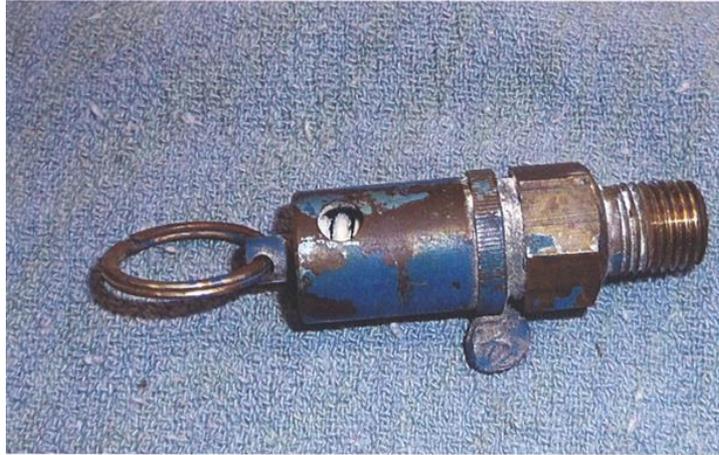
Set at 200, 1<sup>st</sup> pop at  
234 psi

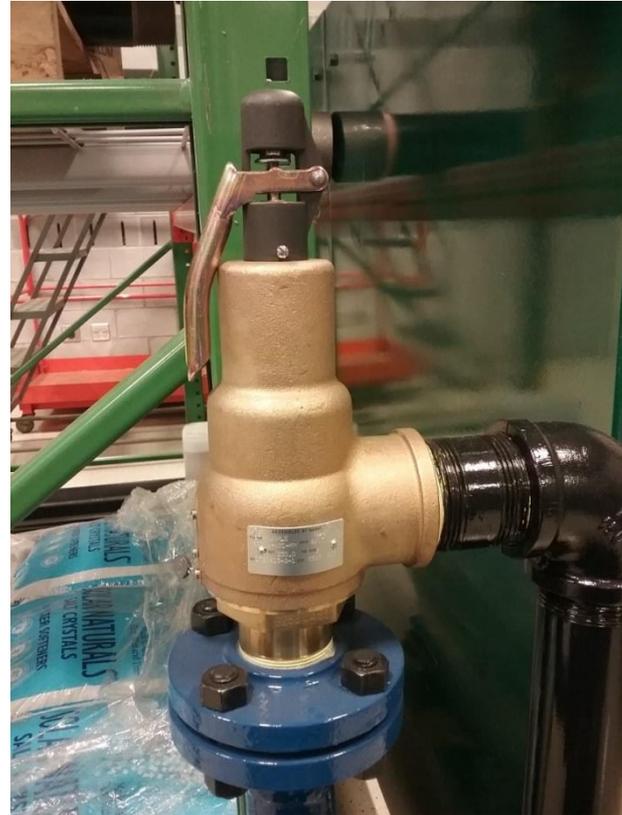
- Lift lever performance checked at 75% of set on 6 valves, all were functional.
- Conclusion: Valves were being tested without pressure under them.

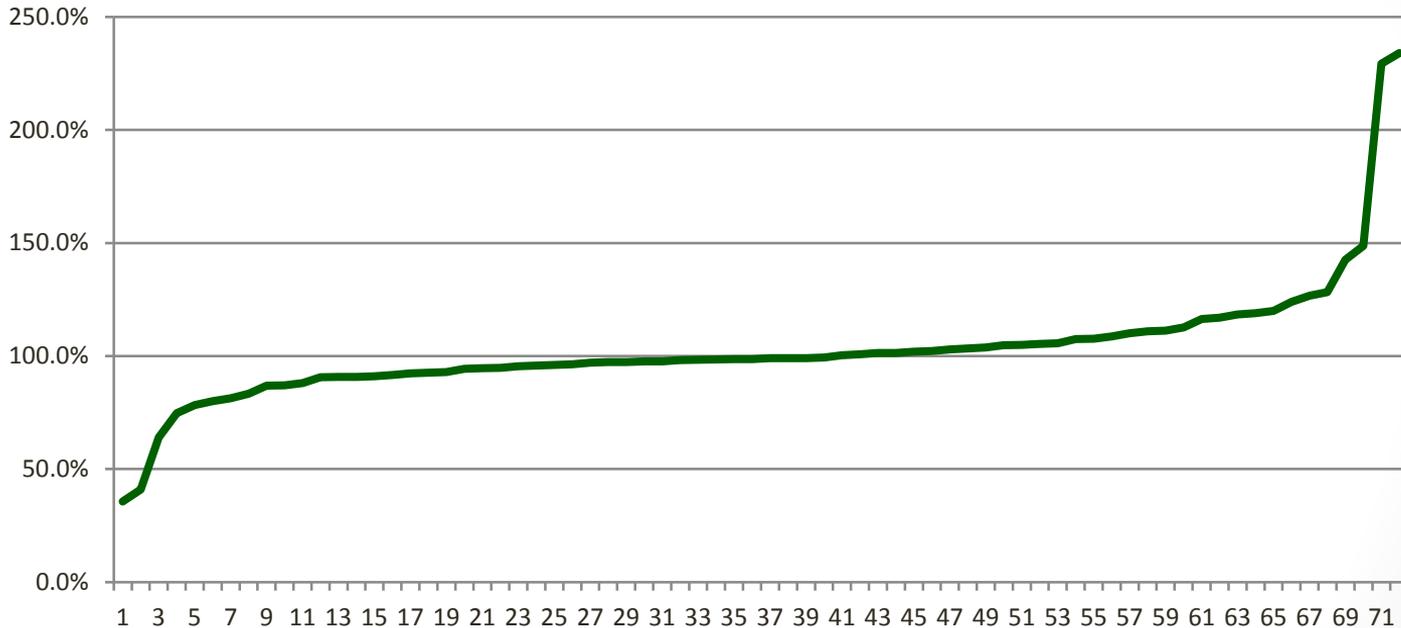
# For 72 Devices that Opened:

## Set Pressure Distribution

- 59% of the objects tested opened at 110% of set pressure or less
- 73% opened at 1.5 times the set pressure or less
  - (13% opened between 1.1 and 1.5 times the set)
- 2 opened above 1.5 x set pressure and 12 were stuck, plugged up or leaking only (14%)
