**THE  
NATIONAL  
BOARD**  
OF BOILER AND  
PRESSURE VESSEL  
INSPECTORS

# **SUBGROUP ON REPAIRS and ALTERATIONS SPECIFIC**

## *AGENDA*

# **Temper bead Repair of T91 Using EPRI P87 Filler Metal**

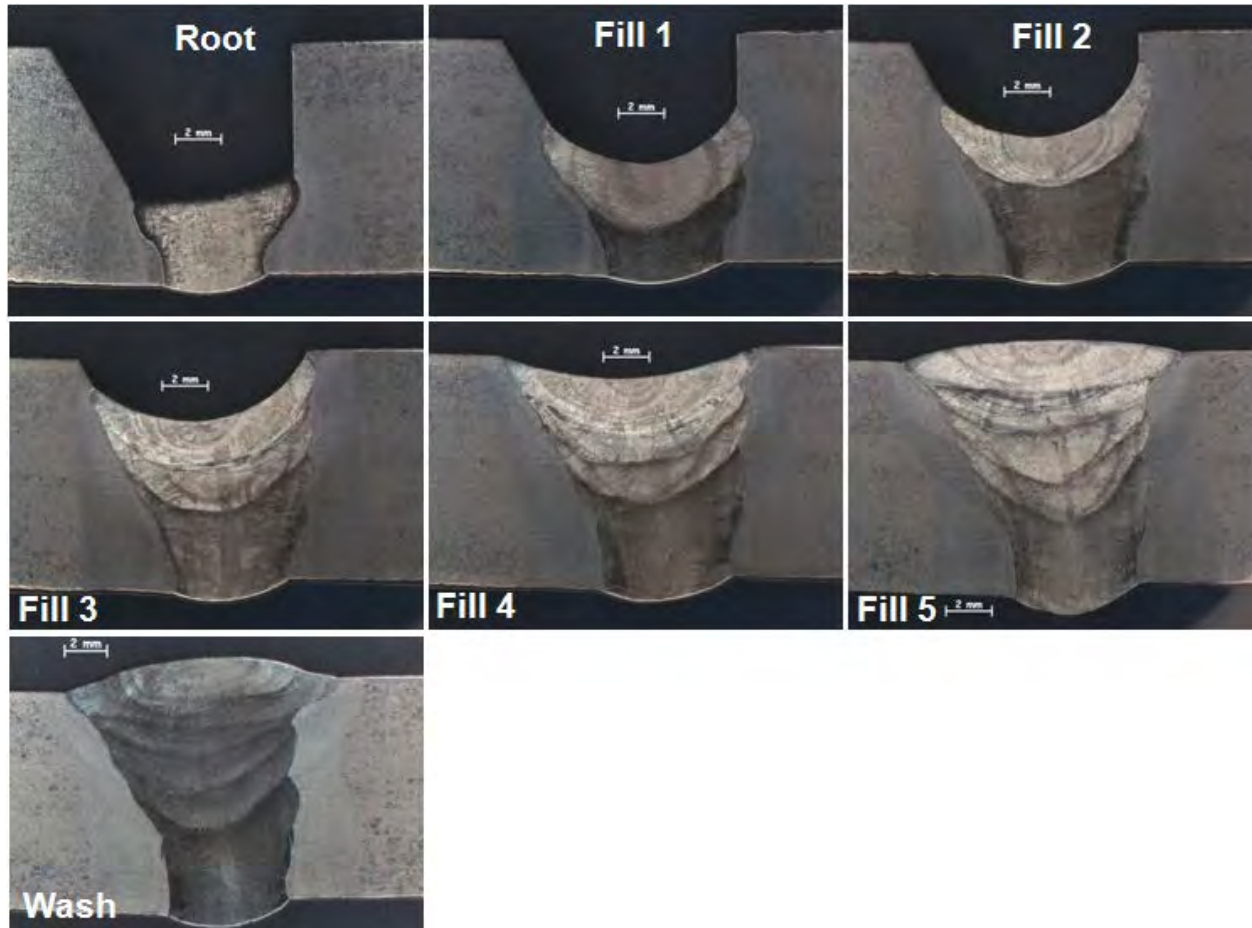
**Figure 12**  
**Consistent Layer Weld Passes**

Macro images for each weld pass in the consistent layer and controlled deposition weldments are shown in Figures 12 and 13, respectively. For each weldment, the width of the HAZ is similar with no major improvement in size or width in the 0° bevel side of the weldment. For the controlled layer technique, the wash pass provided necessary reinforcement to complete the weldment. In the case of the consistent layer technique, the wash pass was not needed to provide sufficient reinforcement. In either case, the wash pass could be ground away in the field should it be deemed excessive.

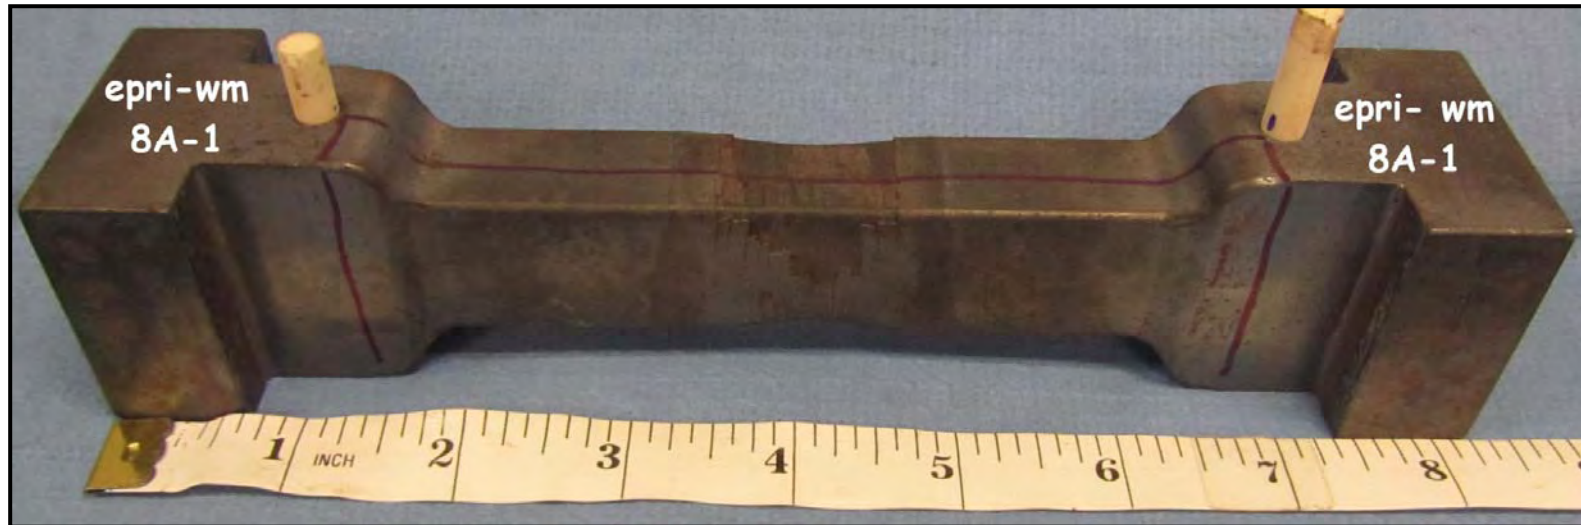
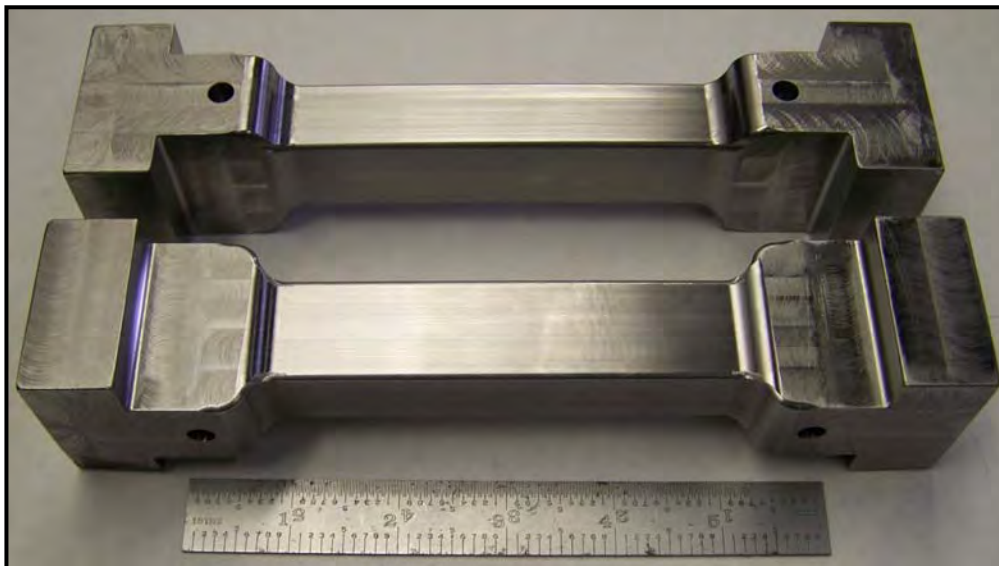
# Machined and Tested Creep Samples

Creep testing being conducted at 625°C, 80MPa (~5,000 hr life)

**Samples include the entirety of the weld metal and temperbead layers on either side of the weld**
