# NATIONAL BOARD Task GROUP LOCOMOTIVE BOILERS

## Minutes

Meeting of July 15<sup>th</sup>, 2019  
Kansas City, MO

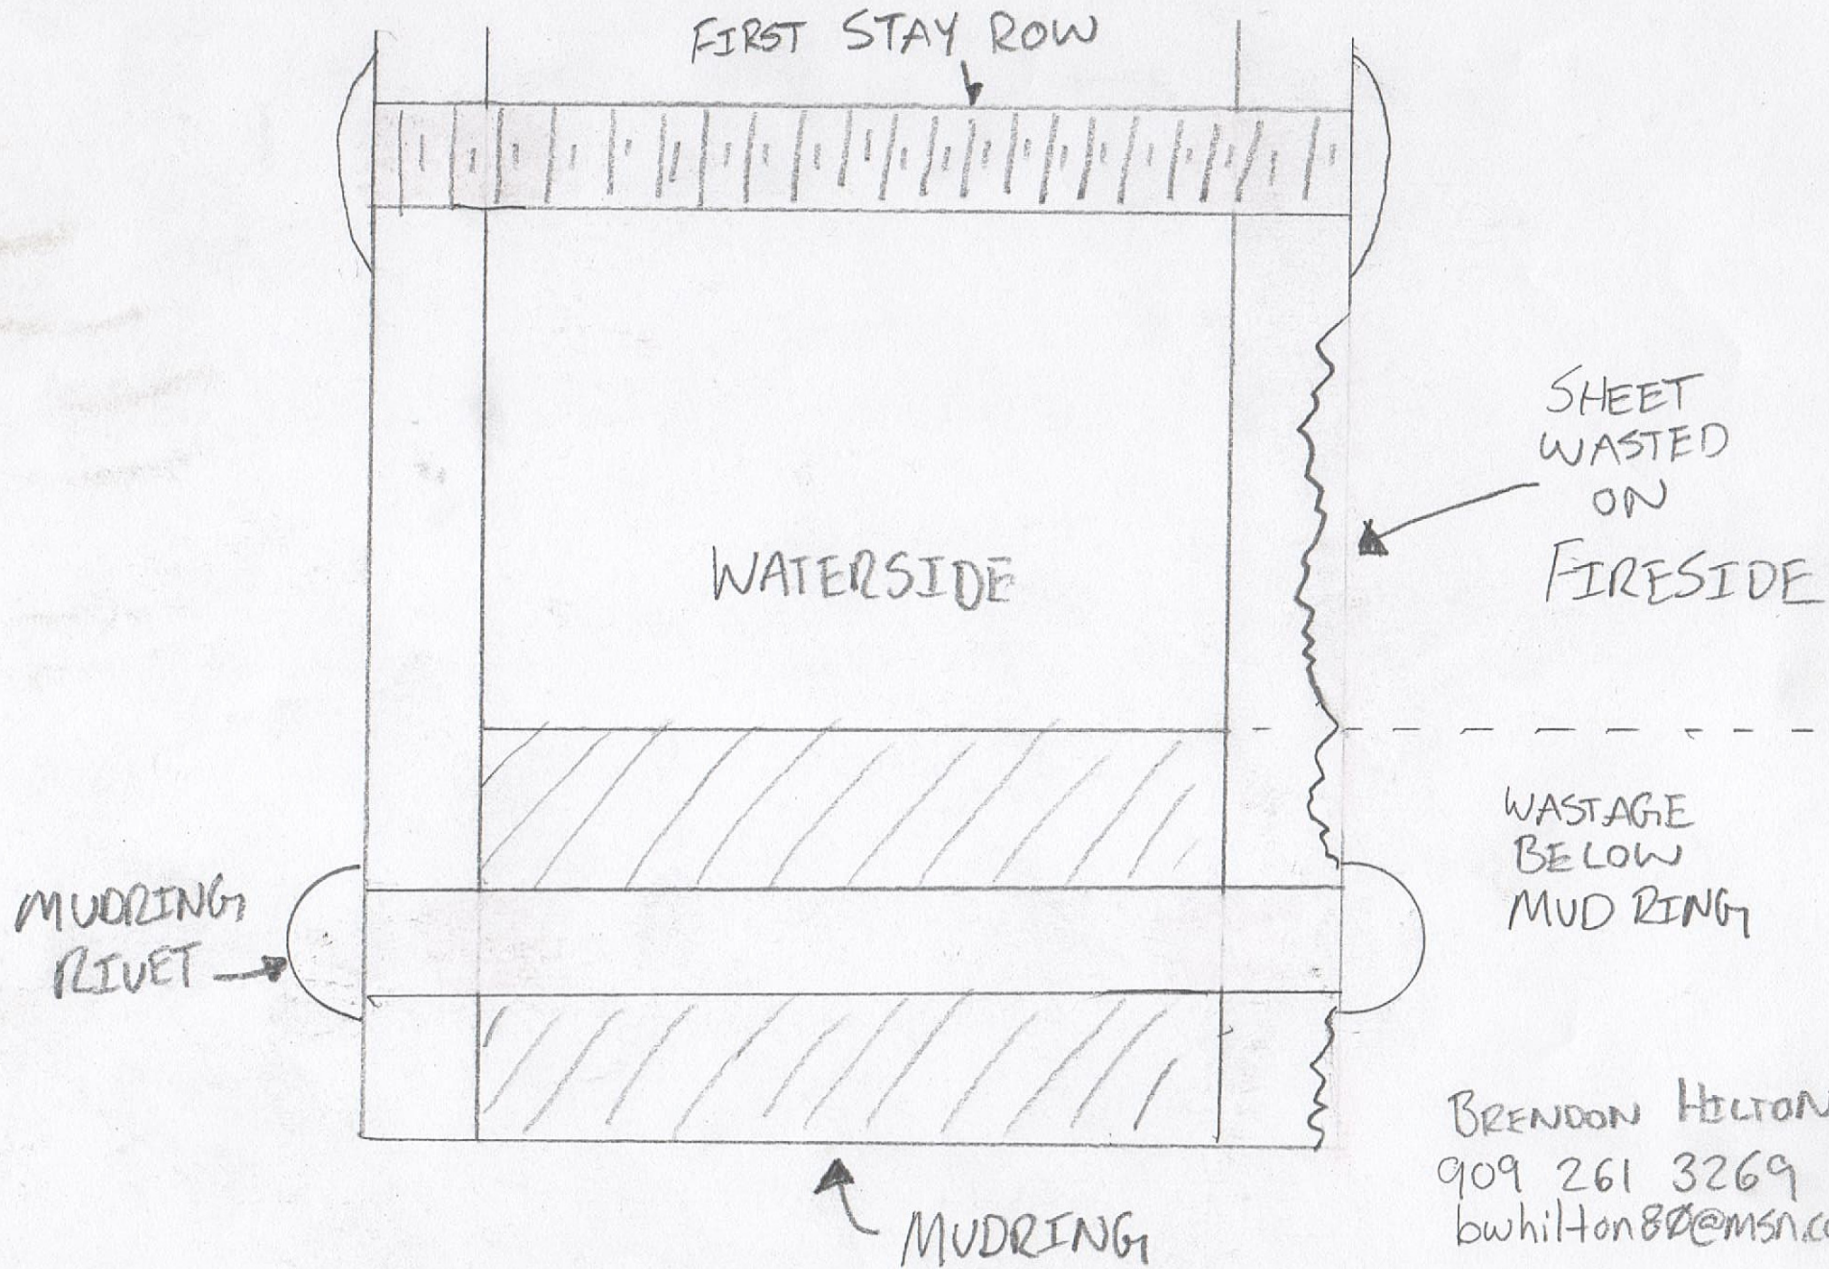
Background - This question is in regards to a CFR 230, 1472 day boiler inspection on a 1927 built Baldwin 4-8-4 steam locomotive. The door sheet (aka back sheet) in the firebox has sustained wastage at the mudring on the fireside, caused by the proximity of the firebrick. In the figure S1.2.11.3, the drawing indicates a wastage on the waterside, yet the text of section S1.2.11.3 does not specify if it is referring to the waterside, the fireside, or both. Please see attached diagram of the wastage in question.

QUESTION: IF THE MAJORITY OF WASTAGE IS ON THE FIRESIDE, DOES  
RULE 5.1.2.11.3 STILL GOVERN REPAIR?

<b>Item Number: 19-17</b>	<b>NBIC Location: Part 3, S1.2.11.3</b>	<b>Attachment Page 6</b>
<p><b>General Description:</b> Wastage at Mudring: If the majority of the wastage is on the fireside, and there minimal wastage on the waterside, does this section still govern repairs?</p> <p><b>Subgroup:</b> Locomotive</p> <p><b>Task Group:</b> None</p> <p><b>Background:</b> This question is in regards to a CFR 230, 1472 day boiler inspection on a 1927 built Baldwin 4-8-4 steam locomotive. The door sheet (aka back sheet) in the firebox has sustained wastage at the mudring on the fireside, caused by the proximity of the firebrick. In the figure S1.2.11.3, the drawing indicates a wastage on the waterside, yet the text of section S1.2.11.3 does not specify if it is referring to the waterside, the fireside, or both. Please see attached diagram of the wastage in question.  <b>July 2019 :</b> moved unanimously</p>

Question - If the majority of the wastage is on the fireside, and there is minimal wastage on the waterside, does NBIC Part 3, 3.3.4.3-a govern repairs?
