**NATIONAL BOARD  
INSPECTION CODE  
SUBGROUP ON HISTORICAL BOILERS**

***MINUTES***

**MINUTES OF SUBGROUP ON HISTORICAL BOILERS  
JULY 16, 2012 COLUMBUS, OHIO**

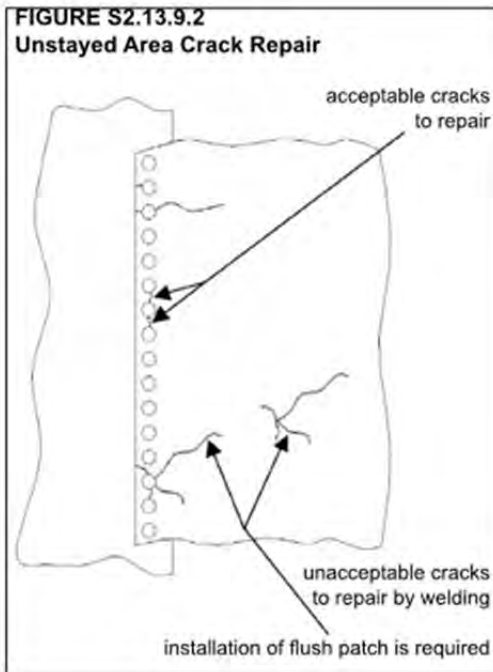
Item # 7 Replace this with the Figure S2.13.9.2-a and Figure S2.13.9.2-b on page 3

1. Remove “See figure S.2.13.9.2” from a).
2. Correct Typo in b) should say Cracks in unstayed not Cracks in stayed
3. Change 8” requirement to insure that the repair is at least 2” from last row of rivets and that preheat is used. Text should be changed to “within 2in. (50mm) from the center line of the outer most row of rivets. Minimum 175 degree preheat shall be used.”
4. Add a reference to figure S2.13.9.2-a in c).
5. Add a reference to figure S2.13.9.2 –b in d).
6. Change girth to circumferential in d)
7. Use new figure S.2.13.9.2-a and S.13.9.2-b

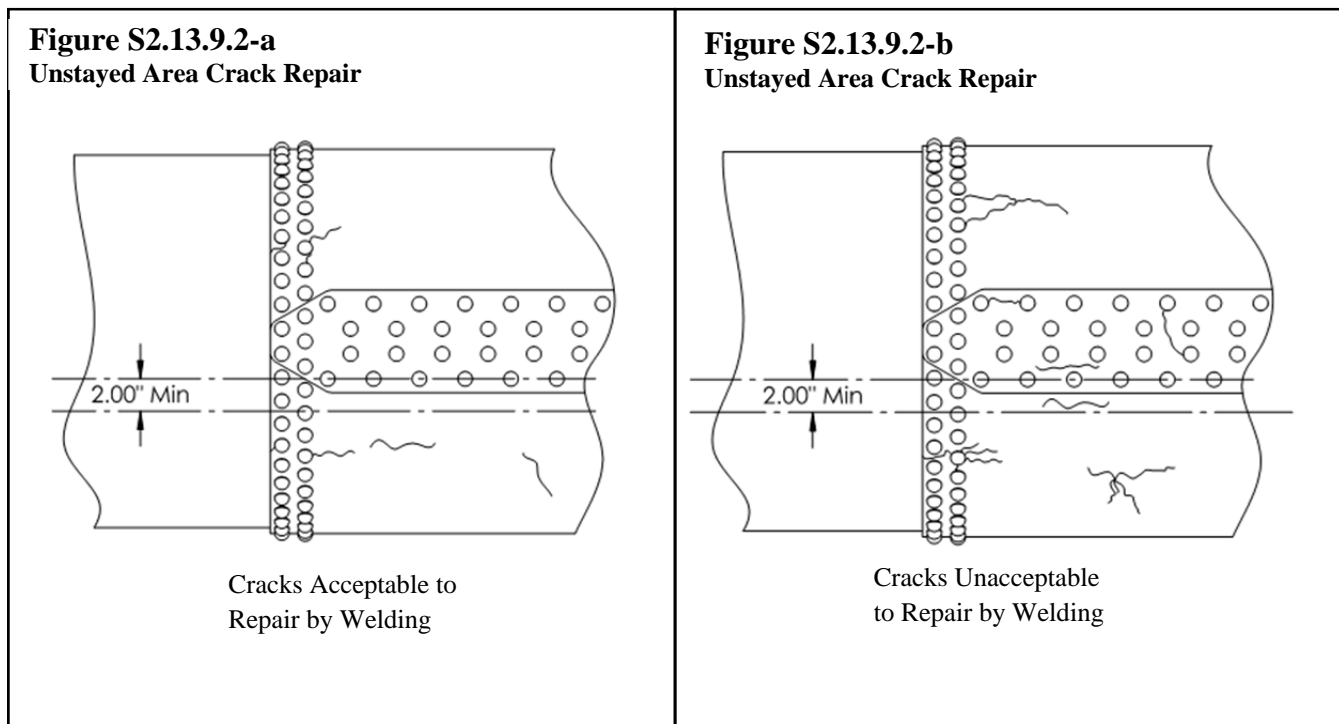
- c) Cracks in unstayed areas may be repaired by welding, providing the cracks do not extend between rivet holes in a longitudinal seam or parallel to a longitudinal seam within 2in. (50mm) from the center line of the outer most row of rivets. Minimum 175 degree preheat shall be used. The complete repair must be radiographed and stress relieved. Alternative methods in lieu of Postweld Heat Treatment identified in NBIC Part 3, 2.5.3 may be used. (See NBIC Part 3, Figure S.2.13.9.2-a)

- d) Cracks radiating from a common point (star cracking) shall not be repaired; installation of a flush patch is required. Cracks radiating from a rivet hole in a circumferential seam may be repaired if the plate is not seriously damaged. (See NBIC Part 3, Figure S.2.13.9.2-b)

Proposal: Update figure S2.13.9.2 to show crack in non-riveted area, update text to fix a typo, move “See figure S.2.13.9.2” and change girth to circumferential.

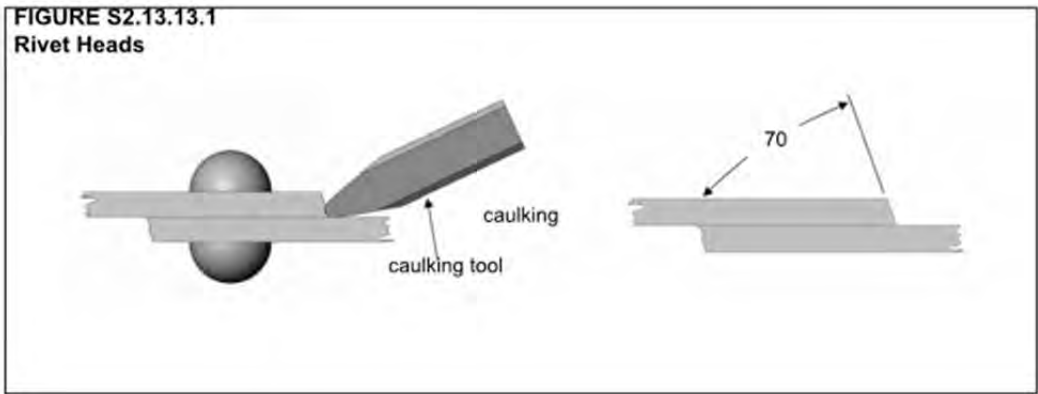
Item #2  
Replace this figure with the one update one on page 3

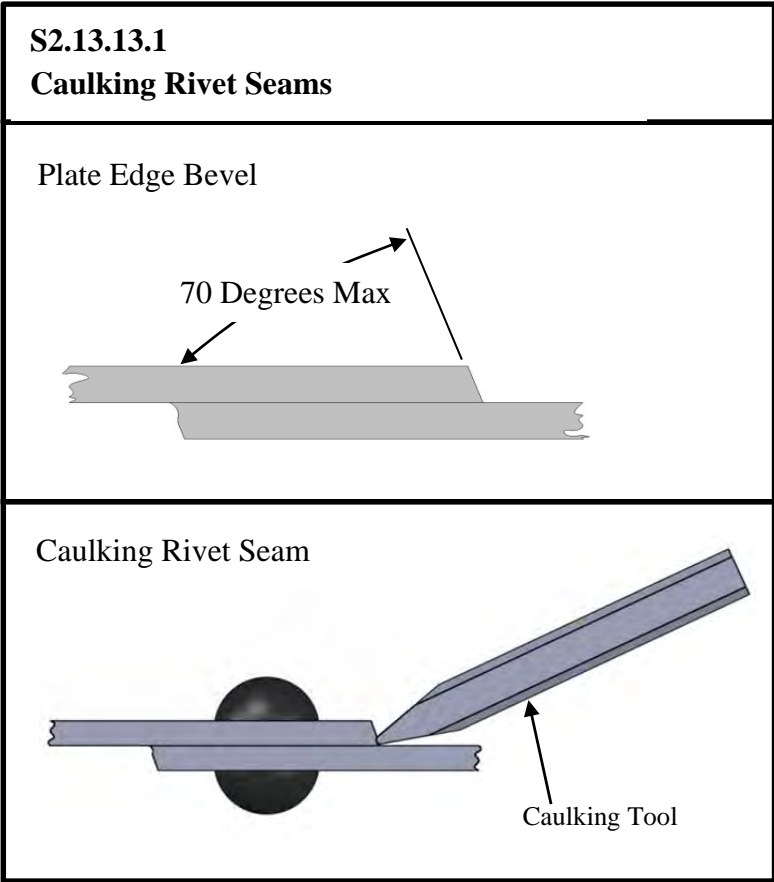
**S.2.13.13.1 Caulking Riveted Seams and Rivet Heads**

a) Caulking refers to the sealing of plate seams and rivet heads by driving the edge of one surface onto the other by use of a caulking tool.

- a) Caulking refers to the sealing of plate seams and rivet heads by driving the edge of one surface onto the other by use of an ~~impact tool~~.
- b) The plate edges should be beveled to an angle not sharper than 70 degrees to the plane of the plate and as near thereto as practicable.
- c) Caulking shall be done with a tool of such form that there is no danger of scoring or damaging the plate underneath the caulking edge, or splitting the caulked sheet.
- d) Riveted seams and rivet heads may be re-caulked after repairs to tighten joint.

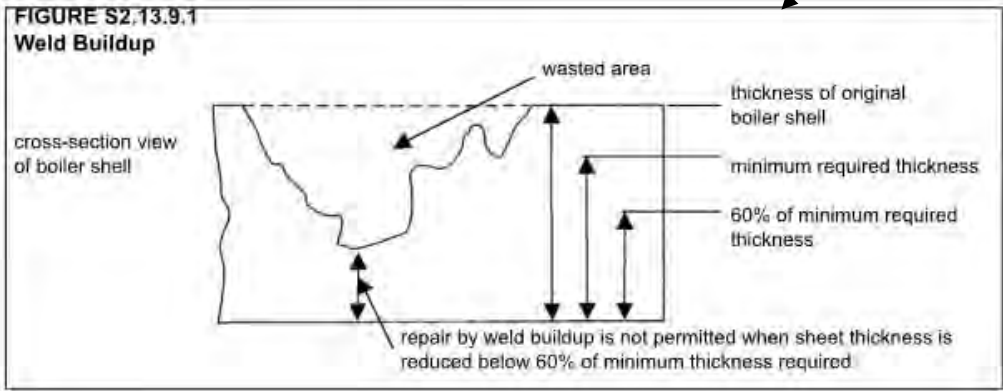
Item # 3 Replace this with the  
 Figure S2.13.9.1 on page 3

- a) Weld buildup shall not be used if the affected section of plate has wasted below 60% of the minimum required thickness per NBIC Part 2, Supplement 2. (See NBIC Part 3, Figure S2.13.9.1).
- b) Wasted sections that have wasted below 60% of the minimum required thickness shall be repaired by installing a flush patch using full penetration welds.

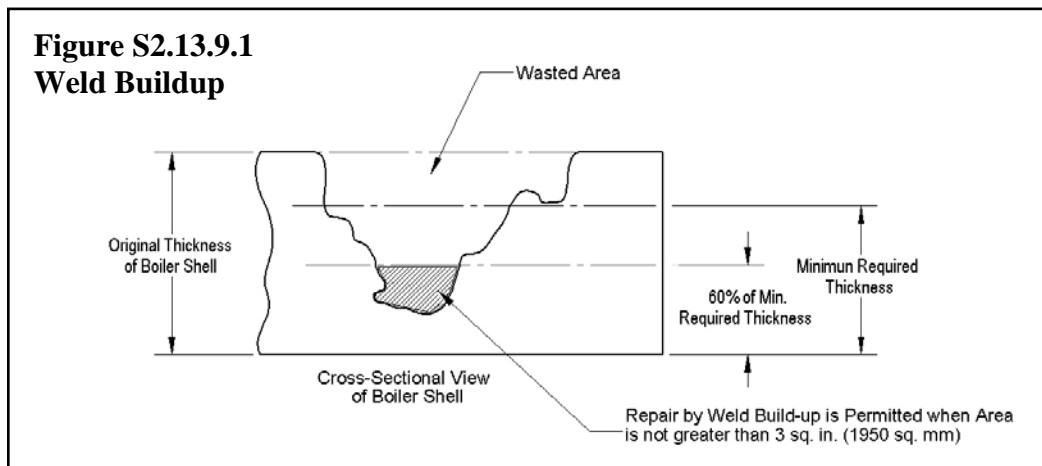
### S2.13.9.1 – Weld Buildup of Wastage and Grooving in Unstayed Areas

- a) Weld buildup shall not be used if the affected section of plate has wasted below 60% of the minimum required thickness per Part 2, Supplement 2 in an area exceeding 3 sq. in. (1,950 sq. mm). (See NBIC Part 3, Figure S2.13.9.1)

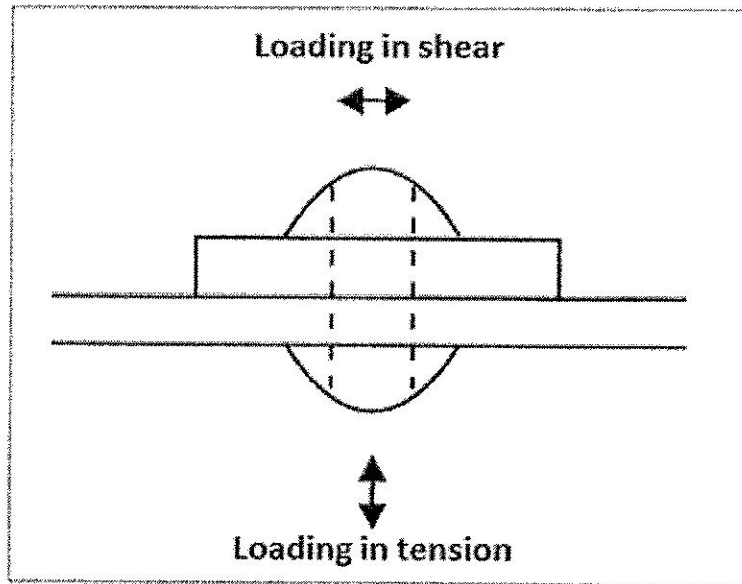
Figure S2.10.2

- iii. For connections subjected to combined shear and tension loads, the amount of measured head deterioration shall not exceed 60% of its total head volume. Where rivets have countersunk heads, the head diameter must be equal or greater than 75% of original head diameter. Application of this value shall take into consideration the consistency and frequency of adjacent rivets showing excessive corrosion.

The condition of the plate surrounding the rivets including general wastage, pitting, and the condition of the caulking edge, must be considered.

**NB11-1603** *Part 2 S2.10.2 SG on Historical Boilers* Define deteriorated rivet heads. A Task Group consisting of Dr. Bryce and Dennis Ruppert was assigned. Dr. Bryce gave a report. A motion was made to accept the proposed text and Figure. The motion was unanimously approved. (Attachment 6)

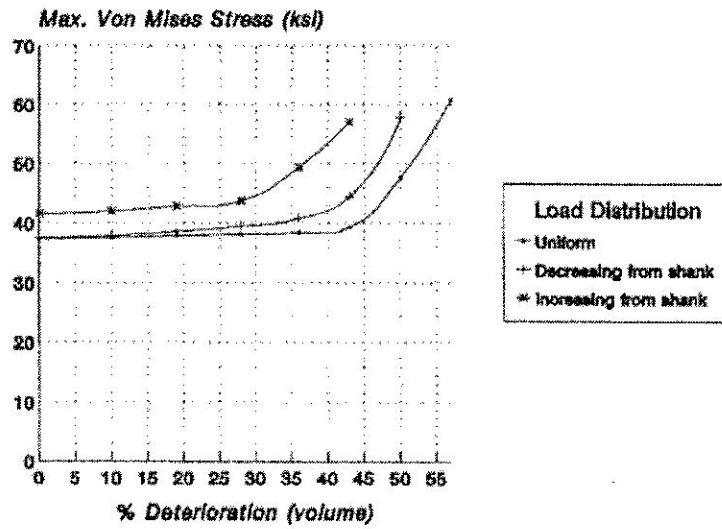
Figure 12 - Max. Stress Vs. Loss of Head Volume (Uniform Model)

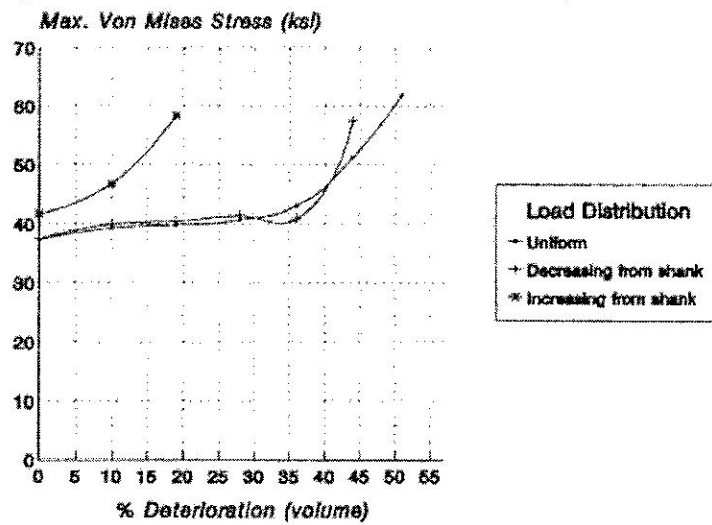
Figure 13 - Max. Stress Vs. Loss of Head Volume (Non-Uniform Model)

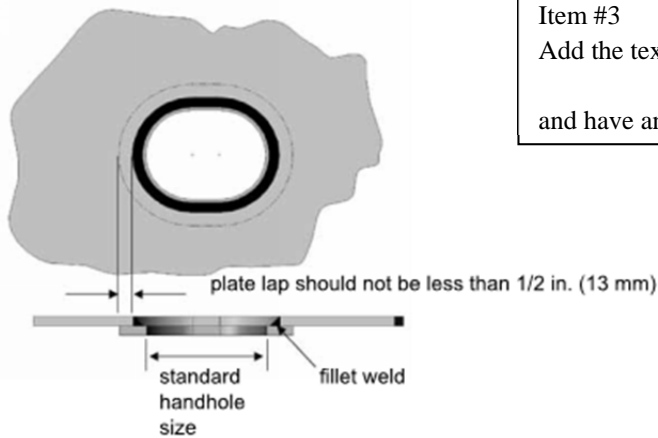
**FIGURE S2.13.14.2**  
**Repair of Handhole Opening**

- b) Weld buildup is to replace material that has been lost due to wastage and grooving, and is not to replace thickness on the opposite side of the sheet. Weld buildup must be applied to the side of the sheet that is wasted or grooved.
- c) Wasted sections that have wasted below 60% of the minimum required thickness shall be repaired by installing a flush patch using full penetration welds or by the installation of a ring on the inside (pressure side) of the sheet. (See NBIC Part 3, Figure S2.13.14.2).
