**THE  
NATIONAL  
BOARD**  
OF BOILER AND  
PRESSURE VESSEL  
INSPECTORS

# **NATIONAL BOARD TASK GROUP HISTORICAL BOILERS**

## **AGENDA**

Meeting of January 13<sup>th</sup>, 2020  
San Diego, CA

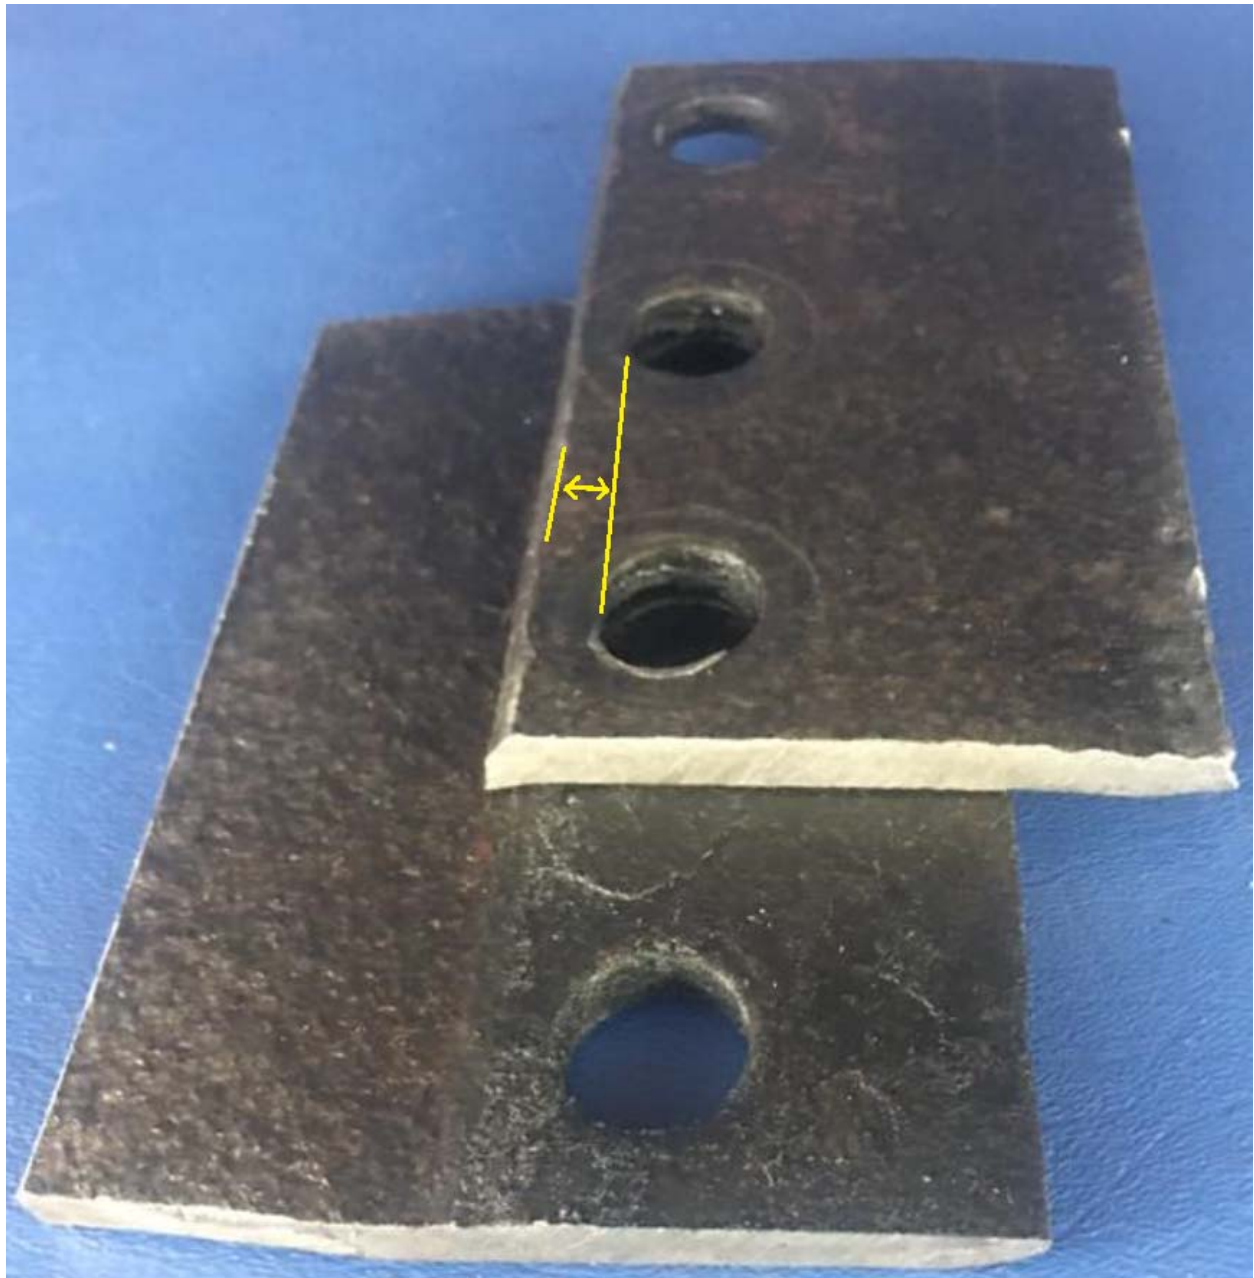
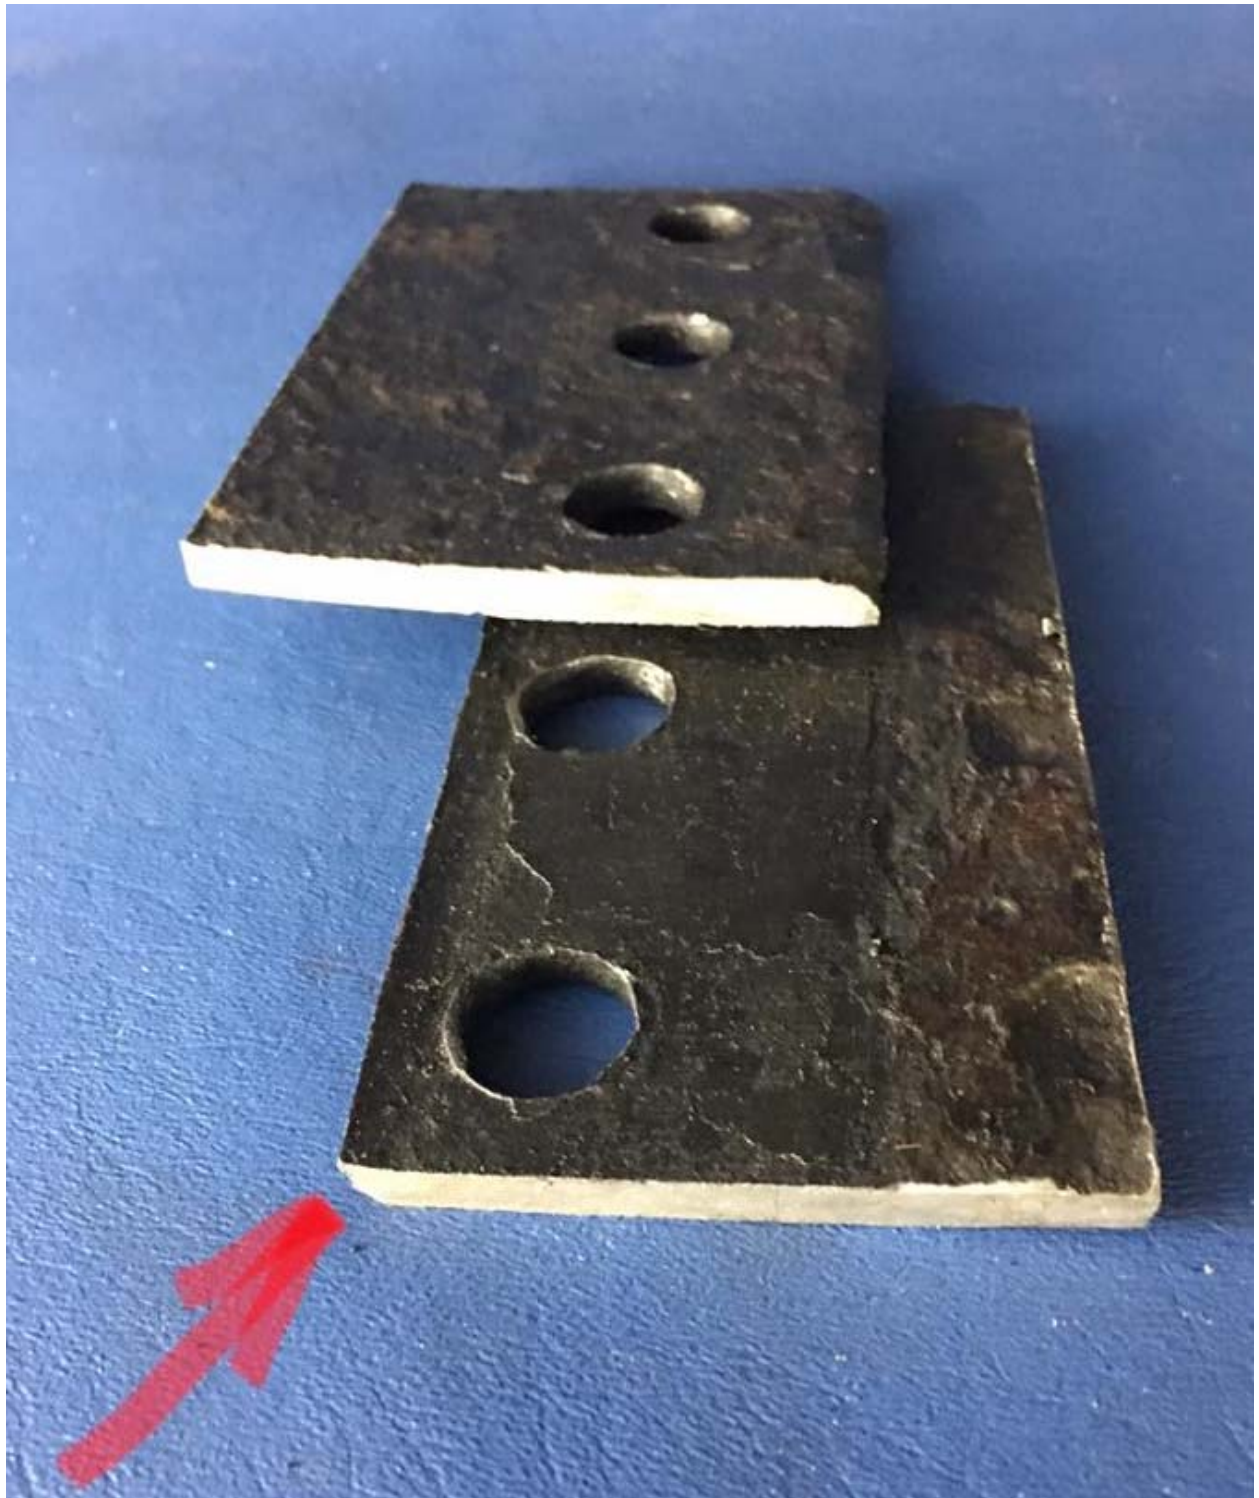
Single-row lap seam from an 1881 6hp Russell traction engine:
