NATIONAL BOARD INSPECTION CODE
SUBGROUP ON
FIBER REINFORCED PLASTIC PRESSURE VESSELS
MEETING OF October 22, 2012
Las Vegas, NV

NB10-0601

INSPECTION OF STATIONARY HIGH PRESSURE
(3000-15000 psi) COMPOSITE PRESSURE
VESSELS**S9.1 SCOPE**

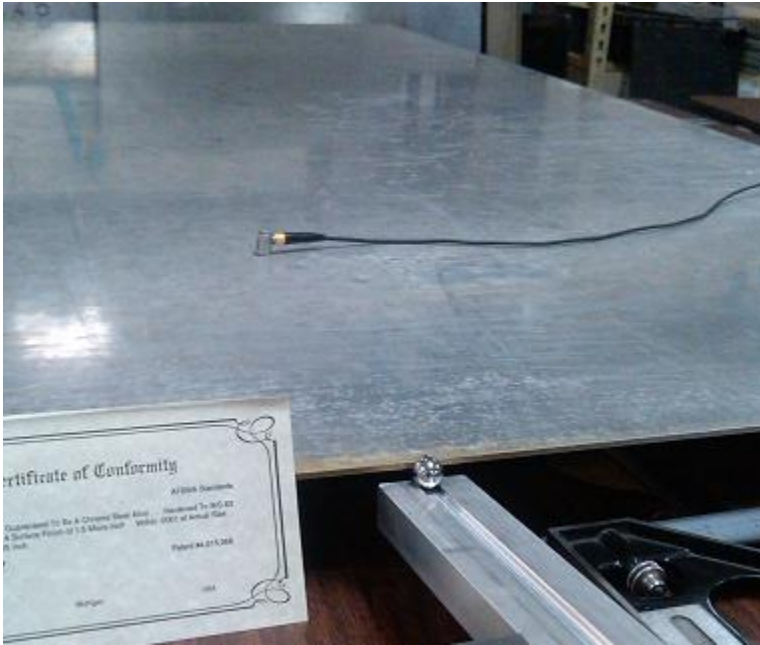
Figure 1. Rolling Ball Impact Calibration Setup.

The impact setup, an example of which is shown in Figure 1, shall be arranged as follows. The steel ball shall be $\frac{1}{2}$ inch in diameter. The steel ball is a type typically used in machine shops for measuring taper and is commercially available. The ball shall be made of chrome steel alloy hardened to R/C 63, ground and lapped to a surface finish of 1.5 micro-inch, within .0001 of actual size and sphericity within 0.000025 inch. The plate shall be made of 7075 T6 aluminum, be at least 4' x 4' in size, the larger the better to avoid reflections, be $\frac{1}{8}$ " in thickness and be simply supported by steel blocks. The inclined plane shall be aluminum with a machined square groove $\frac{3}{8}$ " wide which supports the ball and guides it to the impact point. The top surface of the inclined plane shall be positioned next to the edge of the plate and stationed below the lower edge of the plate such that the ball impacts with equal parts of the ball projecting above and below the plane of the plate. A mechanical release mechanism shall be used to release the ball down the plane.

The ball roll length shall be 12" and the inclined plane angle shall be six degrees. The impact produces an impulse that propagates to sensors coupled to the surface of the plate twelve inches away from the edge. The sensors shall

be coupled to the plate with vacuum grease. The energy of the leading edge of the impulse, known as the wave front shall be measured. The vertical position of the ball impact point shall be adjusted gradually in order to "peak up" the acoustical signal, much as is done in ultrasonic testing where the angle is varied slightly to peak up the response. The center frequency of the first cycle of the E wave shall be confirmed as $125 \text{ kHz} \pm 10 \text{ kHz}$. See Figure 2. The energy value in joules of the first half cycle of the E wave shall be used to scale the fiber break energy in criterion 2, as illustrated there. This shall be an "end to end" calibration meaning that the energy shall be measured using the complete AE instrumentation (sensor, cables, preamplifiers, amplifiers, filters and digitizer) that are to be used in the actual testing situation.

A rolling ball impactor shall be used to create an acoustical impulse in an aluminum plate. The measured energy in the wave shall be used to scale the fiber break energy. This scaling is illustrated later on.

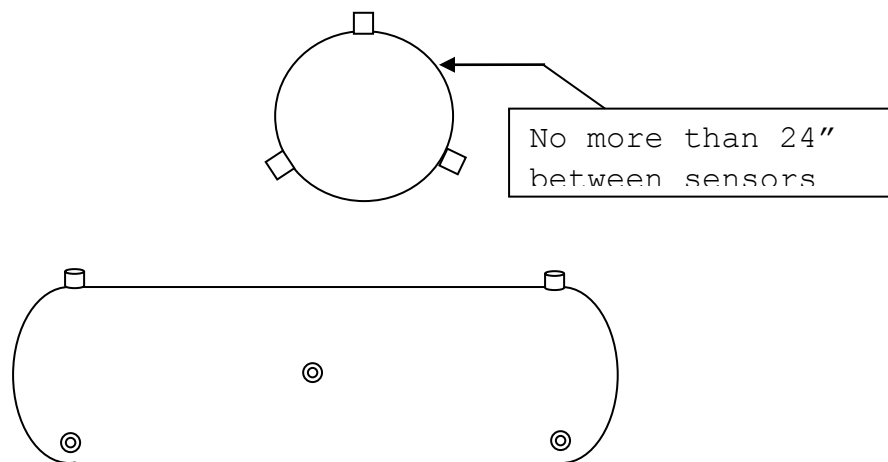
Sensors shall be placed at equal distances around the circumference of the vessel on the cylindrical portion of the vessel adjacent to the tangent point of the dome such that the distance between sensors does not exceed 24 inches. Adjacent rings of sensors shall be offset by $\frac{1}{2}$ a cycle. For example if the first ring of sensors is placed at 0, 120 and 240 degrees, the second ring of sensors is placed at 60, 180 and 300 degrees. This pattern shall be continued along the vessel length at evenly spaced intervals, such intervals not to exceed two feet, until the other end of the vessel is reached. See Figure 3. The diameter referred to is the external diameter of a vessel.

Figure 3. Sensor spacing and pattern.

Maximum distance between sensors in the axial and circumferential directions shall not exceed two feet unless it is demonstrated that the essential data can still be obtained using a greater distance and the authority having the jurisdiction concurs.

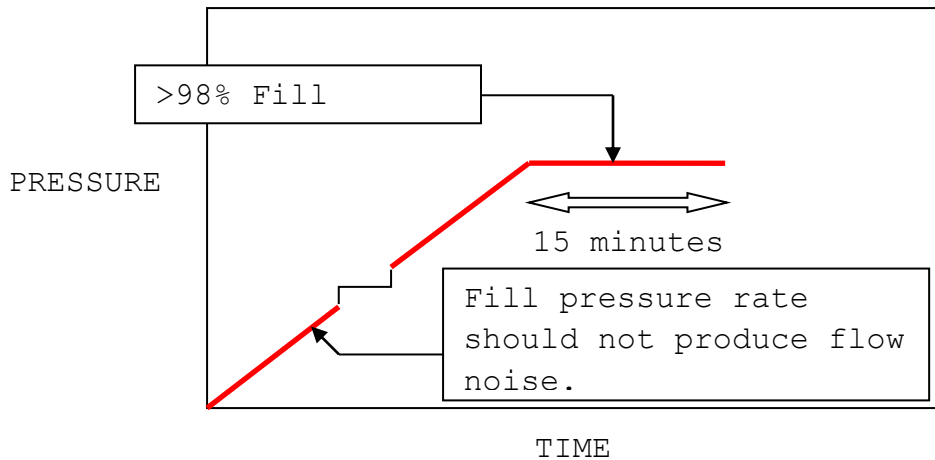
Pressurize vessel to >98% of normal fill pressure and monitor AE during pressurization and for 15 minutes after fill pressure is reached. See Figure 4 for a schematic of the pressurization scheme. If at any time during fill the fill rate is too high in that it causes flow noise, decrease fill rate until flow noise disappears. Record events during pressurization and for 15 minutes after fill pressure is reached and save the data. Then conduct a post-test performance check and save data. Test temperature shall be between 50°F (10°C) 120°F (49°C).

Figure 4. Typical Pressurization Plan When Filling Vessels.

AE shall be monitored for 15 min after operating fill pressure is reached.
